PRELIMINARY REPORT ON THE ACCIDENT INVOLVING AN MD-83 AIRCRAFT BELONGING TO DANA AIRLINES LTD WITH REGISTRATION NUMBER 5N-SRI WHICH OCCURRED AT PORT HARCOURT INTERNATIONAL AIRPORT ON 20TH FEBRUARY, 2018

Registered Owner and Operator:	Dana Airlines Ltd
Aircraft Type and Model:	MD-83
Manufacturer:	Boeing
Date of Manufacture:	October 1990
Registration Number:	5N-SRI
Serial Number:	53020
Location:	Runway 21, Port Harcourt Int'l Airport
Date and Time:	20th February, 2018 @ 1852 hrs <i>(All Times in this report are local, equivalent to UTC+1)</i>

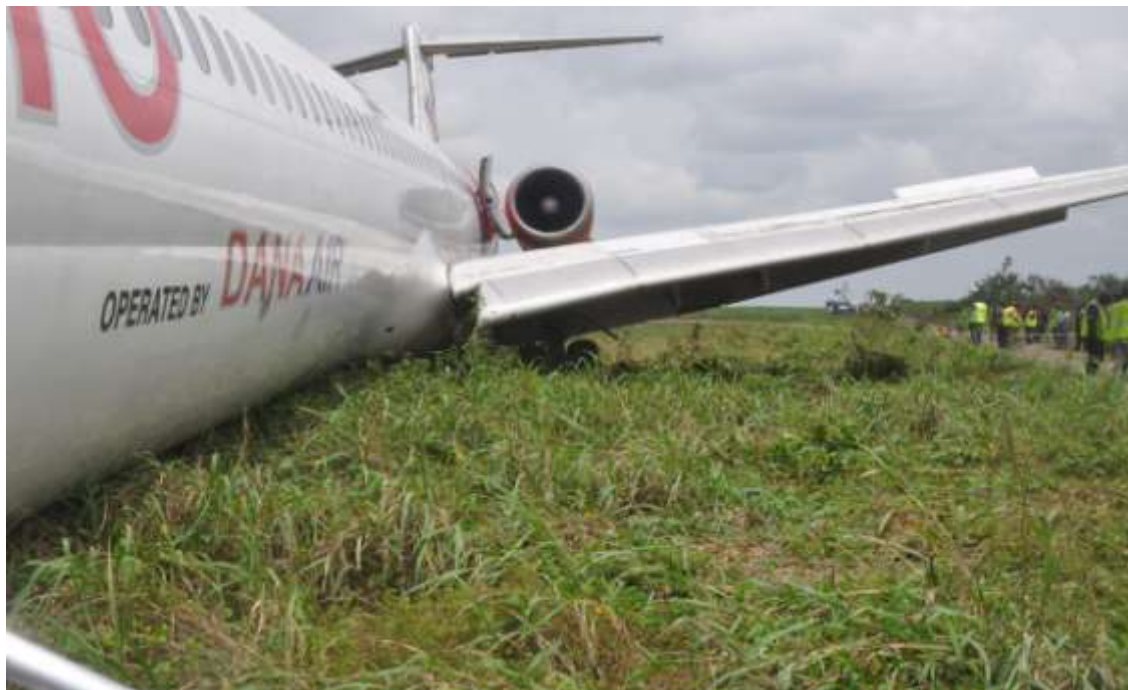
Spoilers and Reversers were deployed and brakes was applied. The aircraft continued on the landing roll, crossed the end of the runway to the blast pad. The aircraft came to a stop at a distance of 298m from the end of runway 21, slightly left of the extended centre line.

Figure 1: Picture showing the final resting point of the aircraft

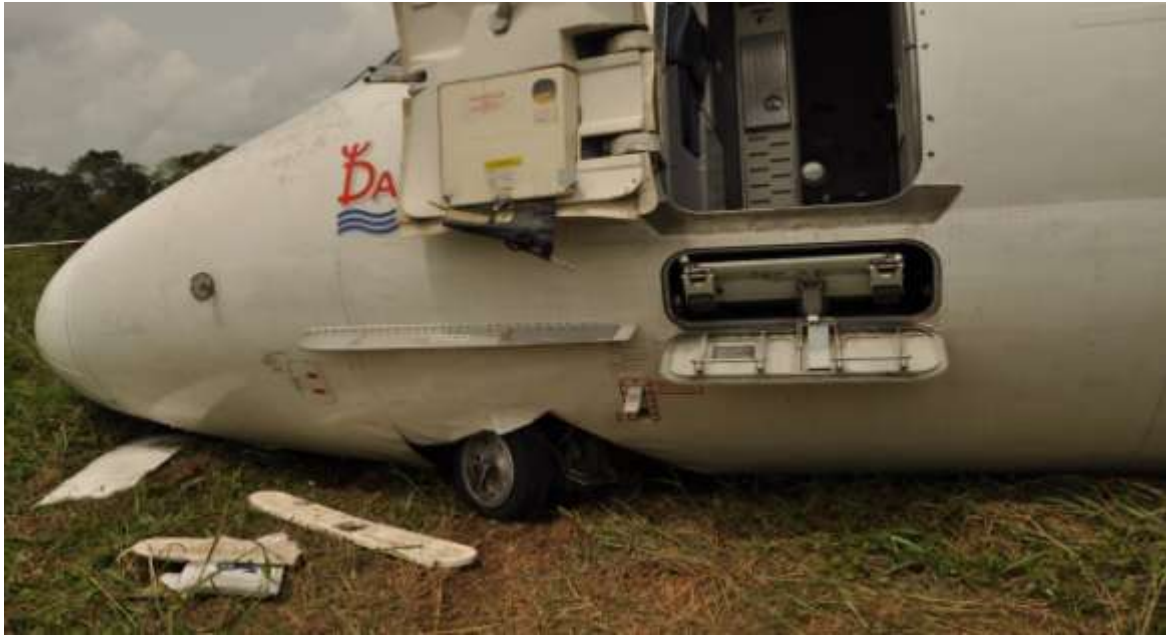
Figure 2: Picture showing the collapsed nose wheel

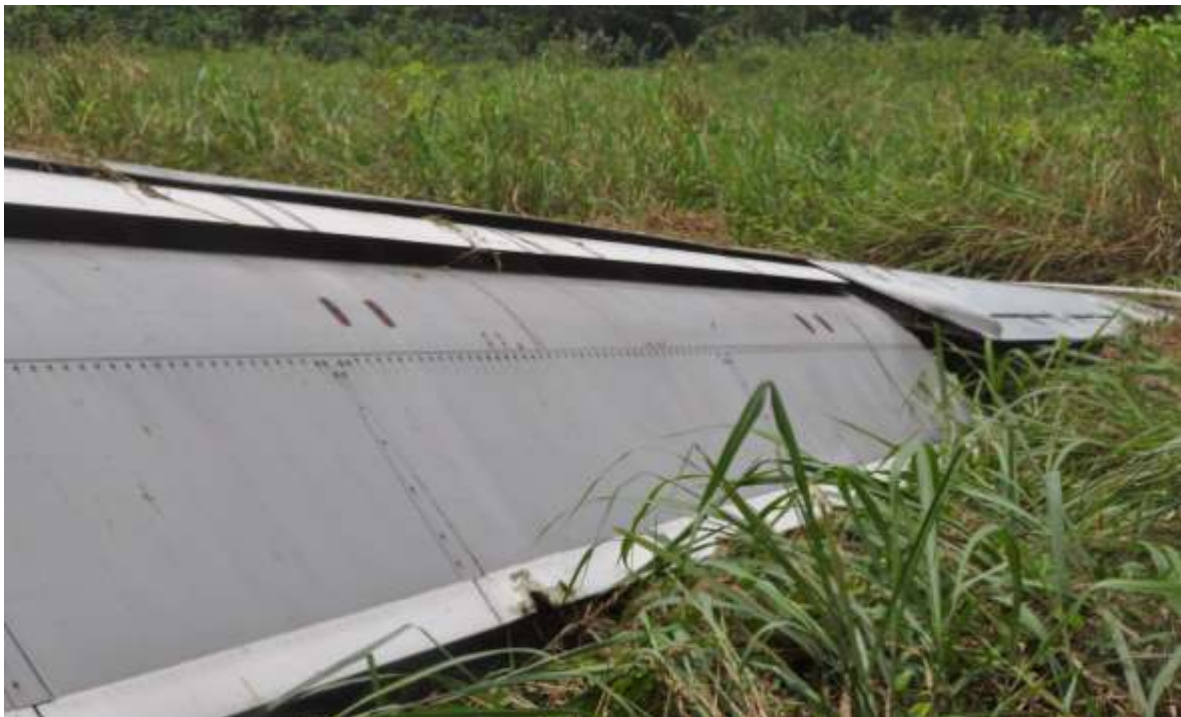
Figure 3: Picture showing damaged right wing

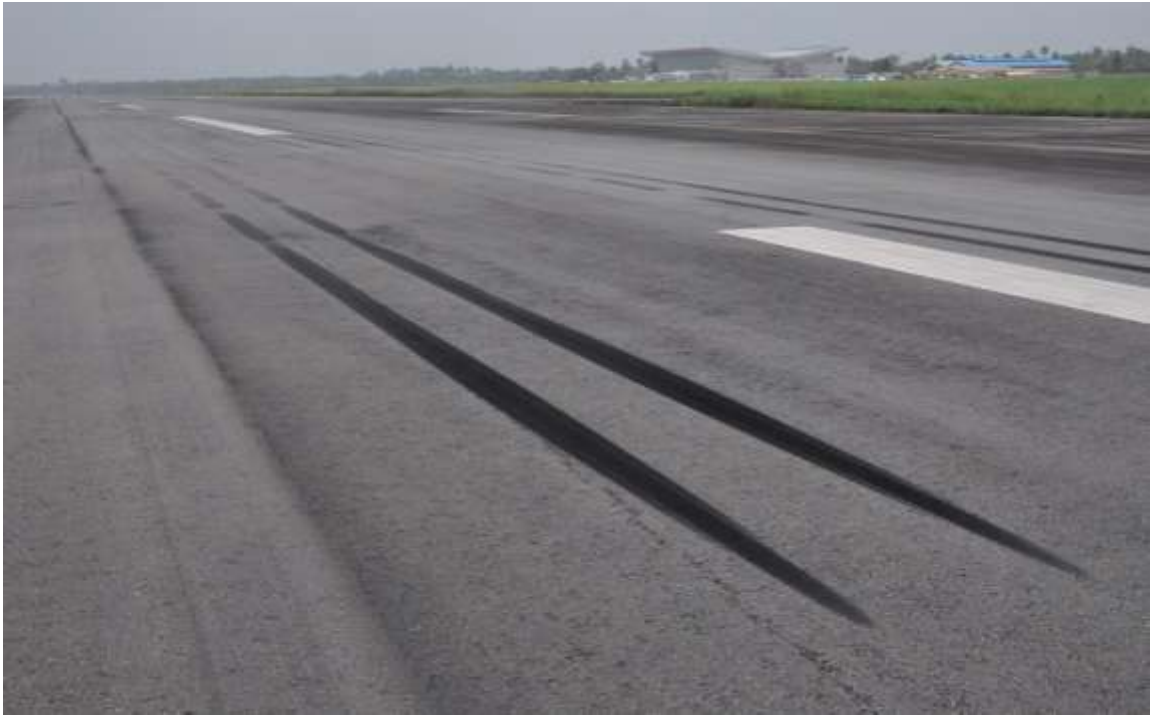
The crew reported that the runway had experienced recent rain before arrival and after touch down, looked and felt contaminated with flood of water that did not drain well.

Figure 4: Picture showing skid marks on the runway
